Upper and Lower Hamburg Bend 2011 Flood Evaluation on the Missouri River near Hamburg, Iowa

January 2017

Final report

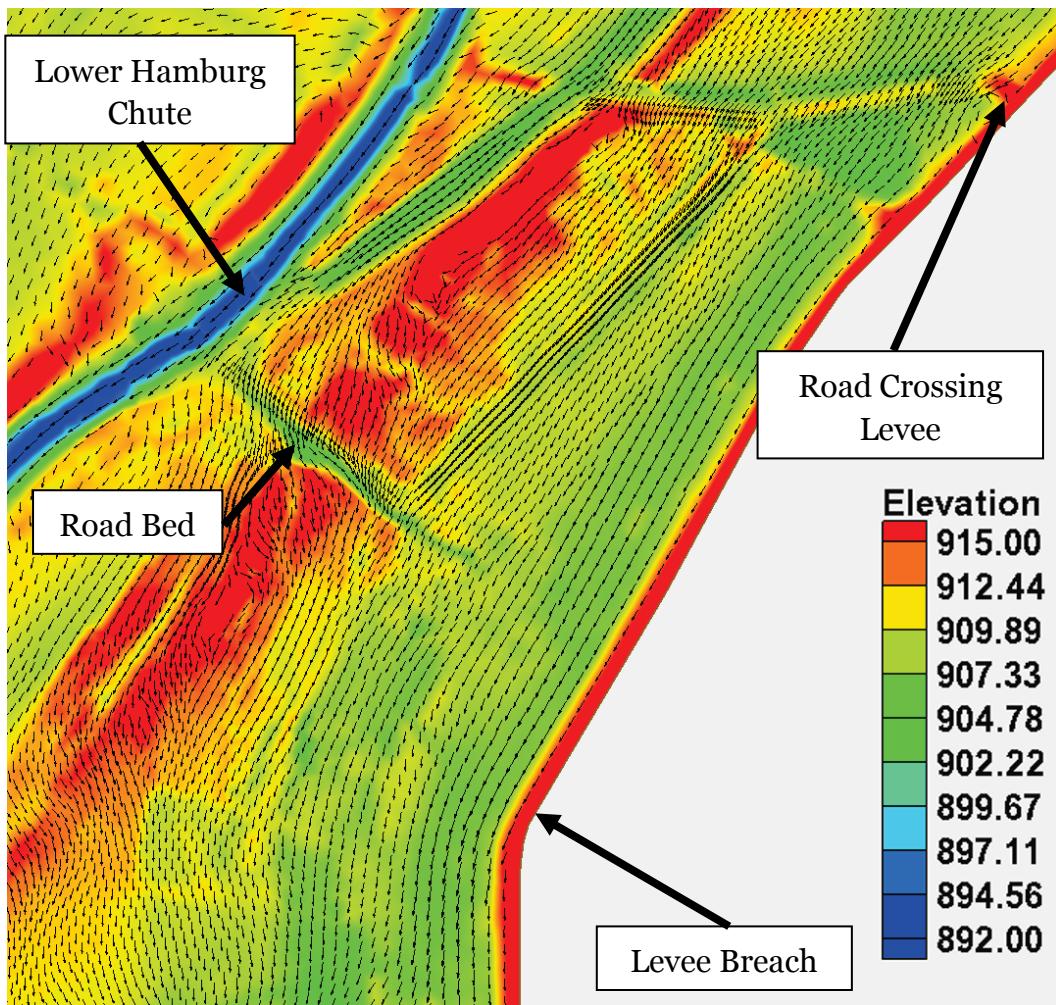
Figure 13. Task 2 model elevation data (ft) overlain with velocity vectors near the levee breach for the 160,000 cfs (4,530.7 cms) flow.

Figure 13 and Figure 14 images also present the direction of the flow over the road crossing at the levee as well as through the opening for the road bed. The figures show multiple areas of the floodplain in which the velocity vector directions are not oriented in the prevailing downstream direction. However, neither velocity vectors toward the levee nor highly turbulent eddy zones were observed in model results within any area where higher velocities were noted. The levee access road ramp (top right corner of Figure 13 and Figure 14) has some indications of an eddy, but it is located in an area with velocities of less than 1 ft/sec (0.3048 m/sec). Vector plots do show areas of flow redirection zones and convergence that indicate areas of non-normal flow patterns. The zones of greatest redirection and/or convergence are associated with the access routes from the levee to the chute as shown in Figure 9 and Figure 14. The access routes have both a varied elevation and roughness compared to the surrounding floodplain

that are possibly the cause of this redirection and/or convergence. The results indicate that the road bed and Lower Hamburg chute, as labeled in Figure 9, do not redirect flow or provide a conduit for impinging flow to the levee.

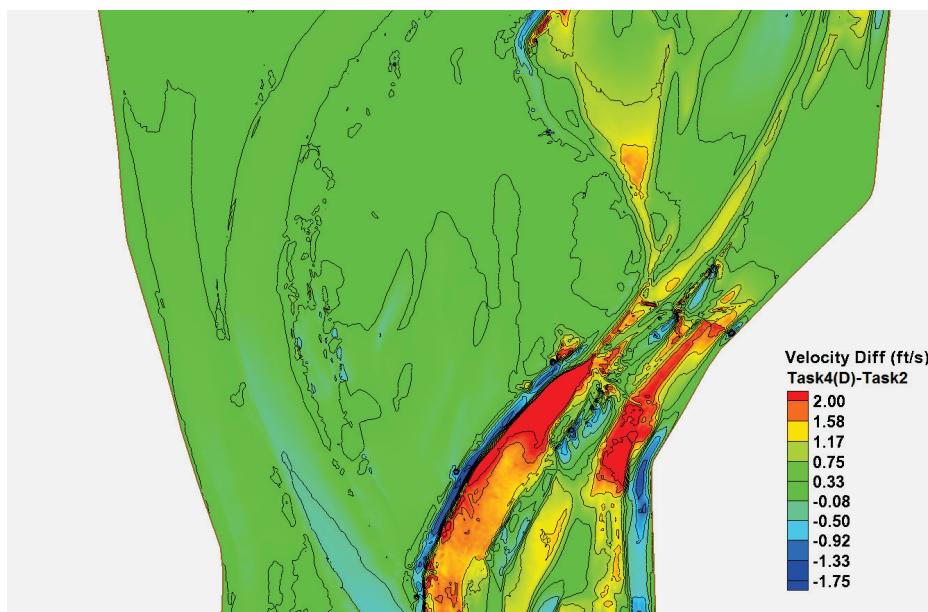
Figure 28. Task 4D – Task 2 velocity magnitude differences (ft/sec) for 160,000 cfs (4,530.7 cms) flow.

These results show that an alternative with all land east of the Lower Chute converted to farmland would have significantly increased nearby floodplain velocities in areas that were dense vegetation but decreased velocities in the near-levee-breach proximity, with a maximum reduction of approximately 1.8 ft/sec, compared to that of the pre-2011 flood conditions. The alternative resulted in much higher conveyance and velocity changes in the area east of the Lower Chute compared to the previous alternatives in both magnitude and area influenced.

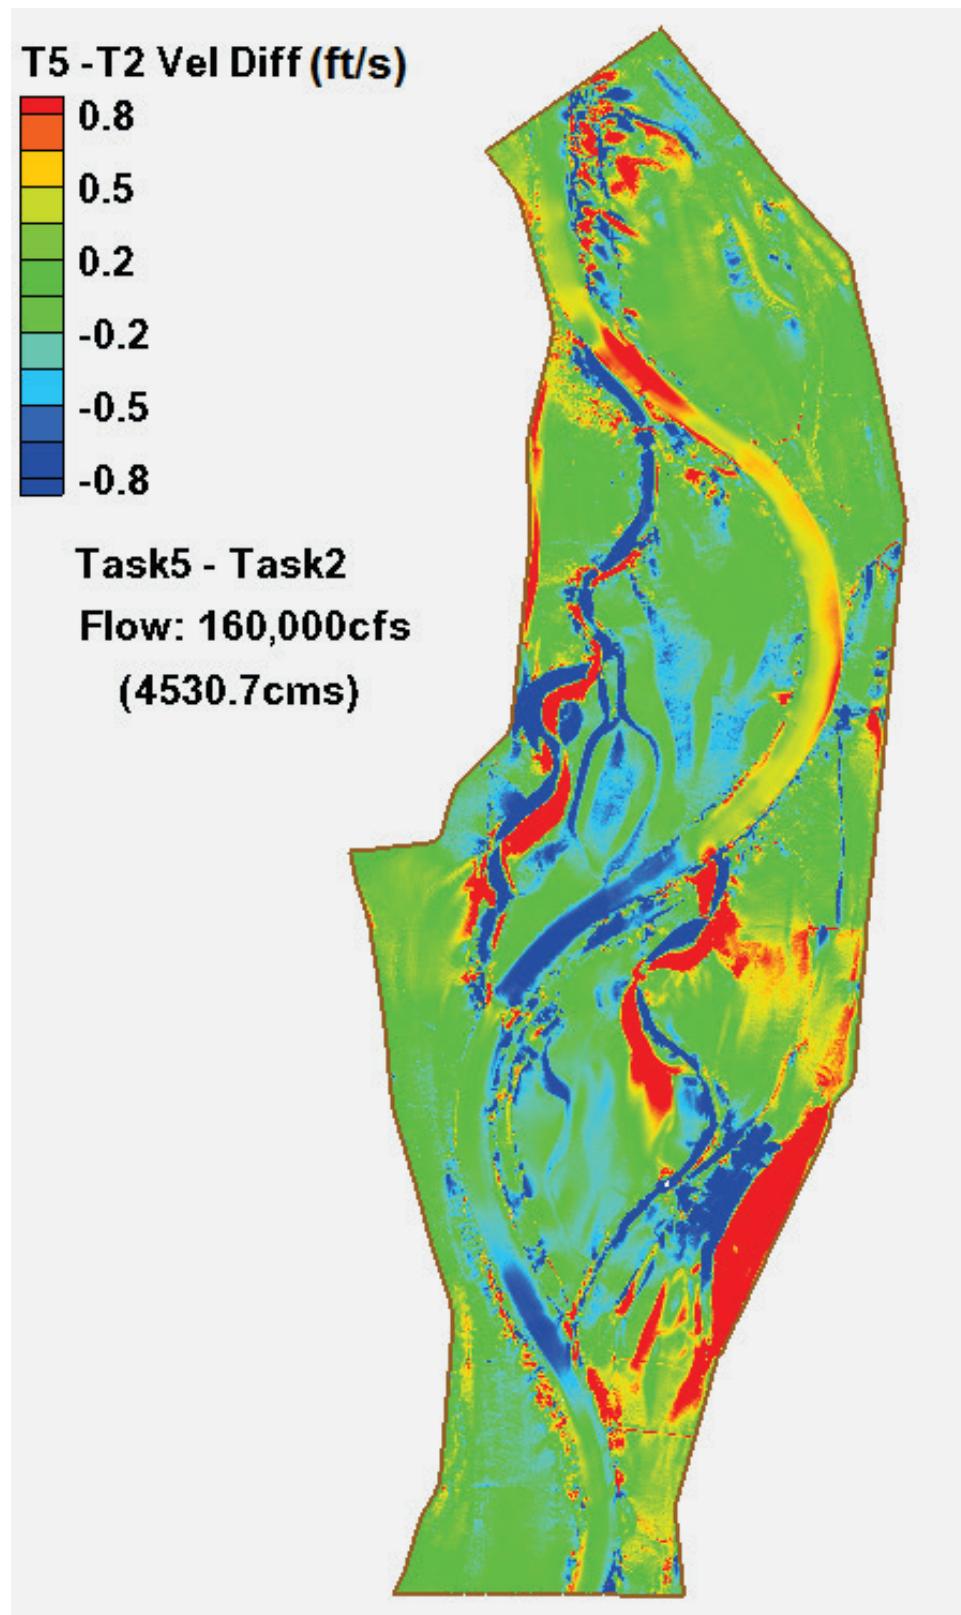
Figure 38. Task 5 – Task 2 velocity magnitude differences (ft/sec) for 160,000 cfs (4,530.7 cms) flow.

Red values indicate higher velocities in the Task 5 model, and blue values indicate lower velocities in the Task 5 model. In portions of the study area where the elevation data of the two task models were significantly different, the utility of this plot is marginal. For instance, the large red crescent just west of the levee setback shows large changes because in the Task 2 model there was no computational mesh in that area, and therefore a value of zero was subtracted from the Task 5 results. No matter what the Task 5 velocities were, the change appears big but is meaningless. The same goes for what appears as big changes in the chutes and anywhere else where large amounts of scour and deposition occurred that changed elevation between the pre- and post-2011 flood geometry. Therefore, the main value in this plot is to note the difference in portions of the floodplain and/or the main channel. In the main channel, it can be seen that velocities are a bit higher upstream of the Lower Chute entrance and slower downstream of the Lower Chute entrance. In the floodplain, increased velocity differences are noticeable just east of the Lower Chute. Also, some higher velocity differences are apparent near the west levee by the Upper Chute and near the east levee north of the levee setback. These two areas are lower velocity magnitude areas and also consistent with elevation differences between the two geometries.

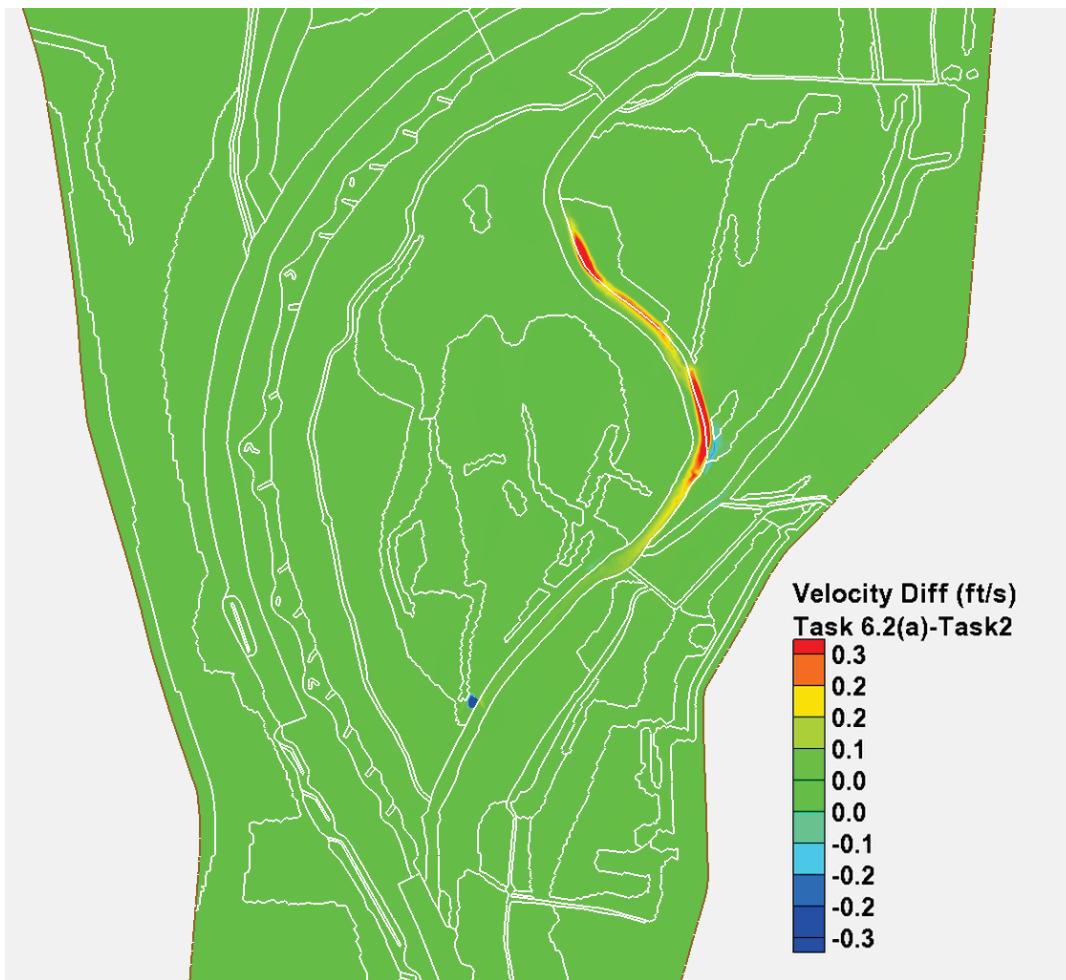
Figure 43. Task 6.2(a) – Task 2 velocity differences for a flow of 160,000 cfs (4,530.7 cms).

The image shows an increase in velocities in the area of the vegetation change and in the chute adjacent to the vegetation change. However, these changes are localized and have little effect throughout the rest of the floodplain.

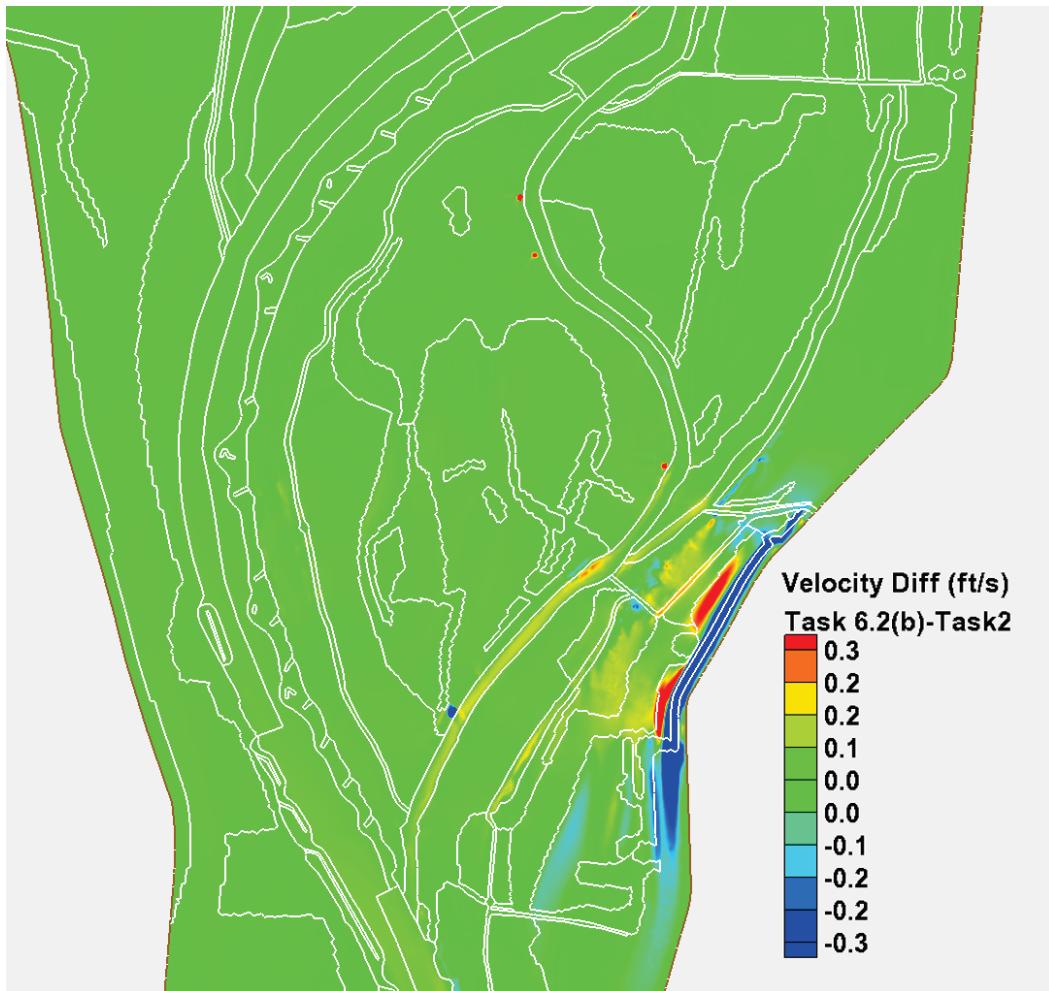
Figure 45. Task 6.2(b) – Task 2 velocity differences for a flow of 160,000 cfs (4530.7 cms).

The image shows a clear reduction in velocities in the area of the trees and adjacent to the levee. This did increase velocities in the floodplain west of the vegetation change but still provides little to no change throughout the rest of the floodplain and model reach.

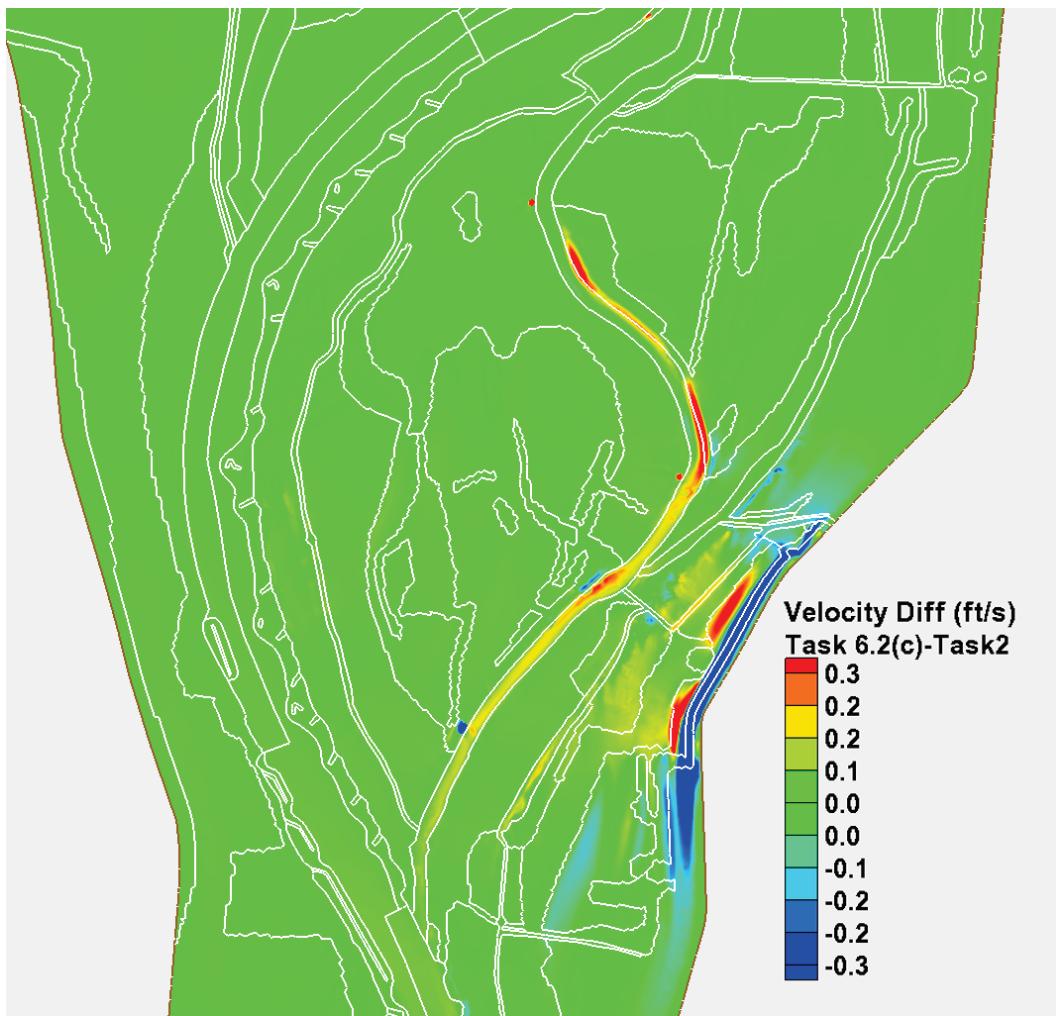
Figure 47. Task 6.2(c) – Task 2 velocity differences for a flow of 160,000 cfs (4,530.7 cms).

The image shows an increase in velocities in the area where the trees were removed and in the chute adjacent to that location and a reduction in velocities in the strip of trees and the area between the strip of trees and the levee. The difference in velocity magnitudes for this alternative is approximately equal to that of Task 6.2(a) and (b) combined. Other than these two local changes in velocities, the vegetative changes have no effect throughout the majority of the floodplain except for the slight increase in velocities between the chute and the strip of trees adjacent to the levee.

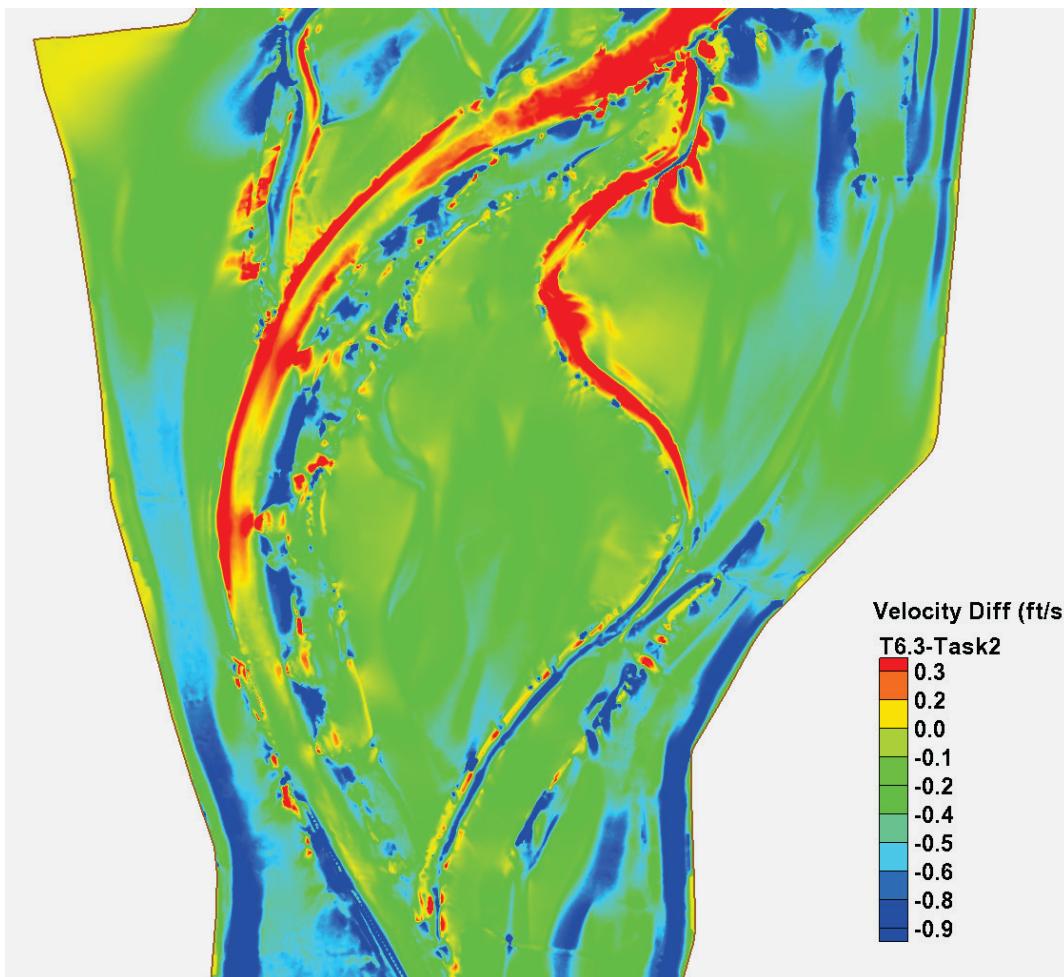
Figure 53. Zoomed view of Task 6.3 – Task 2 velocity differences for a flow of 160,000 cfs (4,530.7 cms) in the Lower Chute.

The velocities in the area surrounding the levee breach were decreased by over 0.9 ft/sec (0.274 m/sec) as the conveyance in the main channel and chutes was greatly increased, therefore lowering the floodplain conveyance and flow velocity. This large velocity decrease provides an indication of dynamic conditions that would have been experienced during the 2011 event.

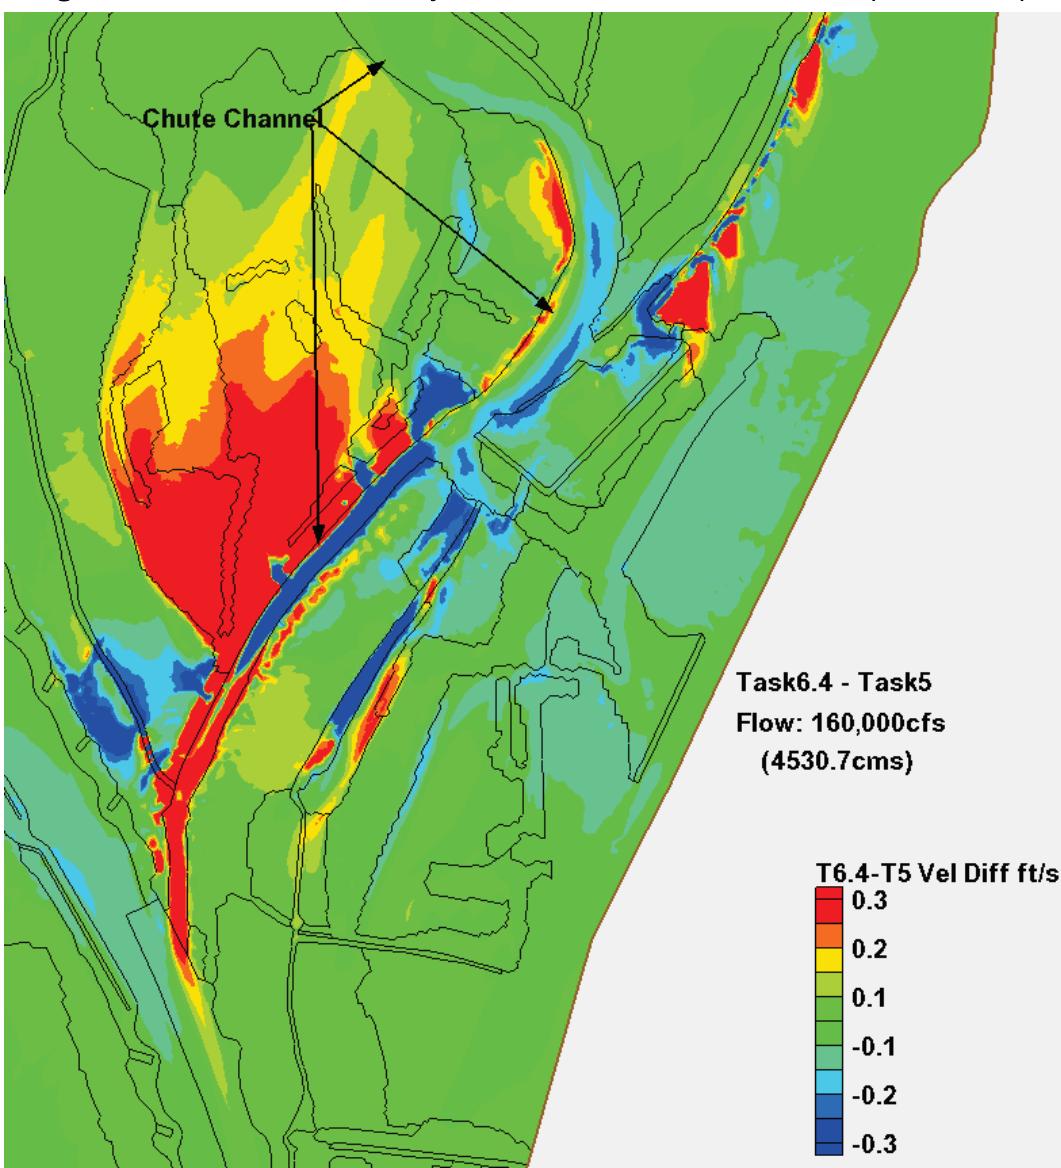
Figure 57. Task 6.4 - Task 5 velocity differences for a flow of 160,000 cfs (4,530.7 cms).

Red and yellow colors show an increase in velocity by removing the side-cast spoil berms, and blue shows a reduction in velocity. Green shows no change in velocity. In the vicinity of the levee setback, there was no noticeable change in velocity, showing that removing the berms has a neutral effect on flow adjacent to the levee.

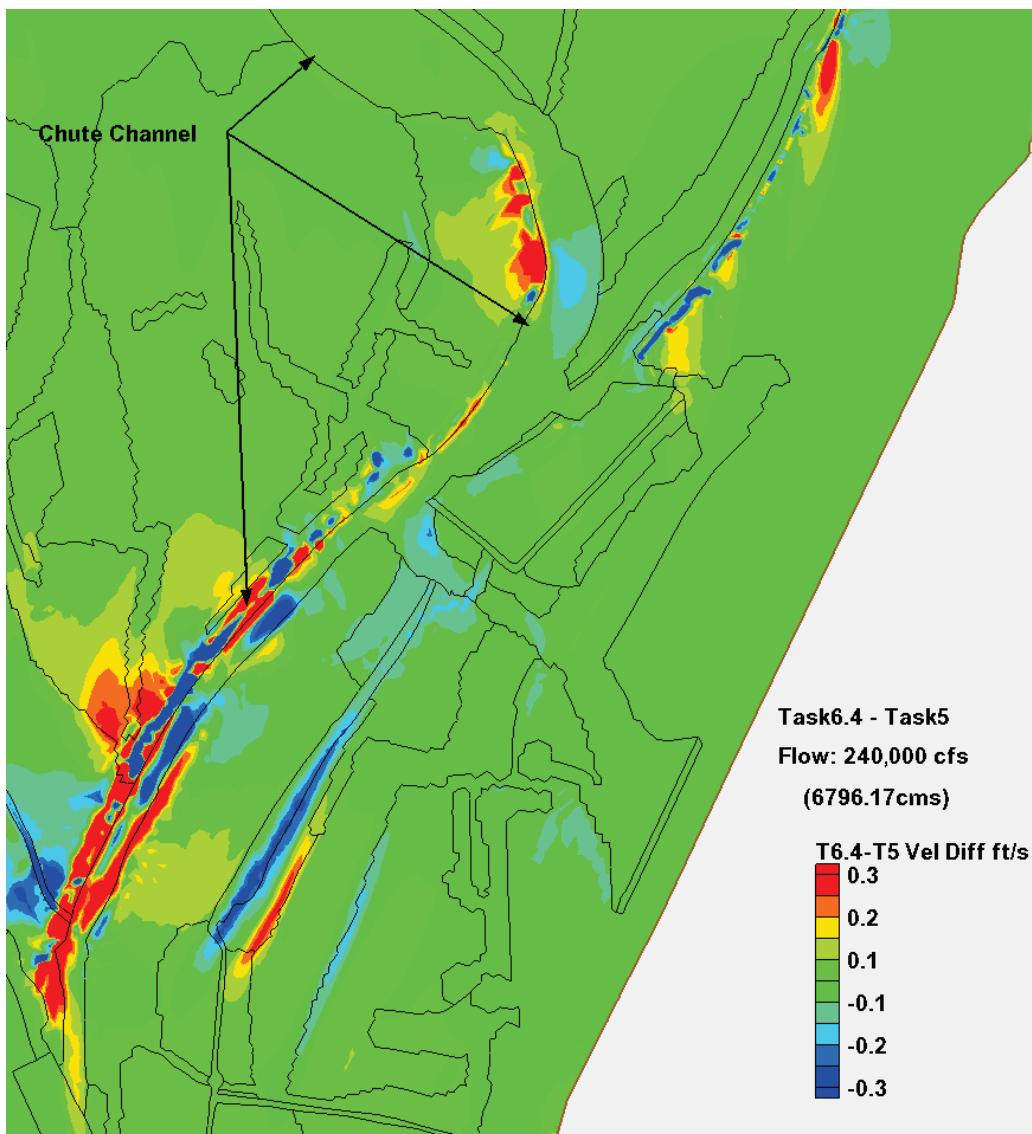
Figure 58. Task 6.4 - Task 5 velocity differences for a flow of 240,000 cfs (6,796.17 cms).

and higher inundation level, the removal of the berms has a lesser effect. As with the lower flow, there is a neutral effect on flow adjacent to the levee setback. A small, yellowish patch just south of the bend near the bottom of the figure is due to the model wetting and drying effect at that location because the simulated flow partially inundates the ground elevation there. Its value is negligible since the water depth associated with this location is basically zero.
